**Hazardous Materials Building Survey
prior to Building Refurbishment at:**

ANZAC Park West and Cafeteria

July 2004

ANZAC Park West and Cafeteria, Campbell ACT Hazardous Material Survey

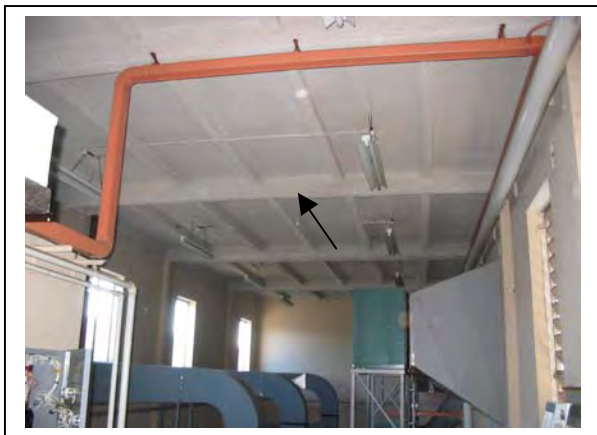
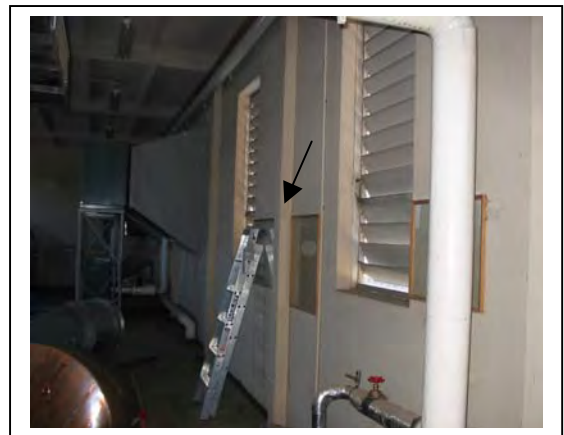
The results of the analysis of the insulation material sampled from the Anzac Park West, Block 1 - Roof Plant Room ceiling and pillars confirms that Chrysotile Asbestos is present. This material is in fair condition however the material is deteriorating and was found on the floor of the plant room. The asbestos is bound in a soft compressed matrix and has the potential to release fibres if disturbed.

Plates 1 and 2 : Plant Room limpet spray insulation on ceiling and wall pillars

If the immediate cleanup of the insulation and sheet debris cannot be scheduled the plantrooms must be labelled appropriately and an Asbestos Management Plan is required (Refer *Asbestos Code of Practice - Section 3.1 & 3.6 & Section 8 Table 1 - Appendix A*).

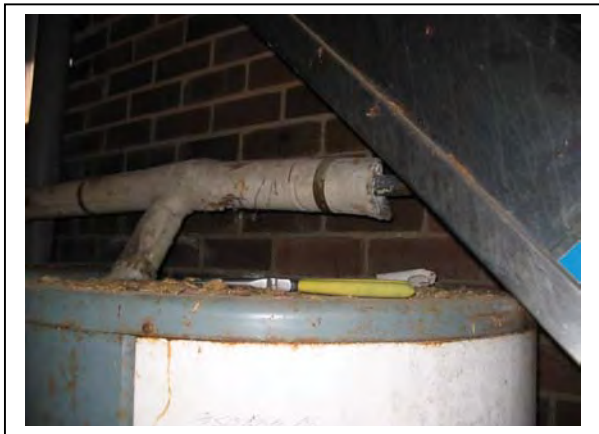
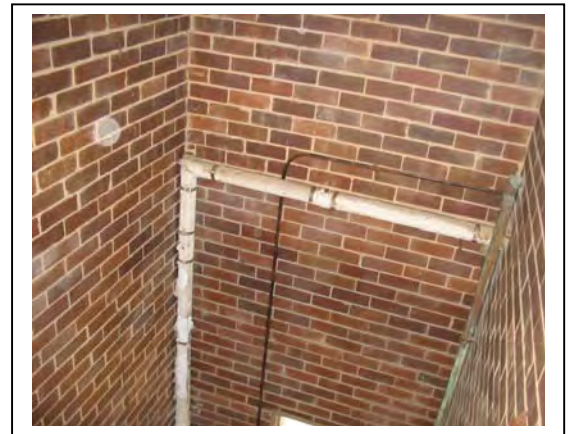
- The pipe lagging is generally in poor condition and will further deteriorate with age and impact damage.
 - The pipe lagging and lagging debris in the plant room is likely to be disturbed by demolition and maintenance personnel during routine maintenance which may cause elevated fibre levels.
 - The asbestos cement pipe debris in the Block 1 Basement South Delivery Room and outside on the Exterior Northeast corner of the building may be disturbed by demolition and maintenance personnel during routine maintenance which may cause elevated fibre levels.
-

Plates 3 & 4: Pipe Lagging to Hot Water Pipes in Cafeteria Plant Room

- Where practicable without causing undue concern to future personnel who occupy the premises during normal building usage, all asbestos material remaining in situ should be clearly labelled i.e. risers and plantrooms must be labelled. Regular inspections are required to assess for deterioration (Refer *Asbestos Code of Practice - Section 3.1 & 3.6 - Appendix A*).
- Prior to any planned demolition, refurbishment or maintenance, its effect upon any in situ asbestos must be established by reference to this document, including amendments.
- If immediate removal of all asbestos is not planned an Asbestos Management Plan is required (Refer *Asbestos Code of Practice - Section 8 Table 1 - Appendix A*).

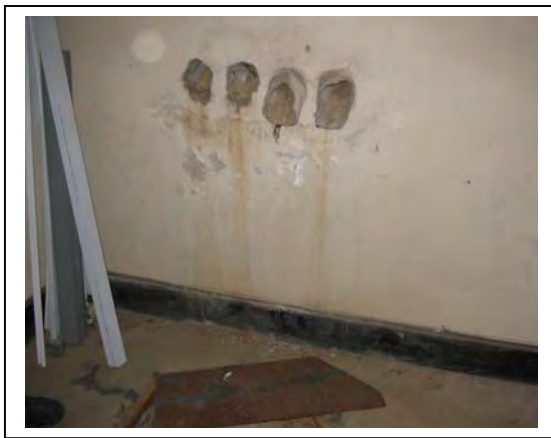
Plates 5: Damaged Asbestos Cement Pipe – Block 1 Basement; Delivery Room South.

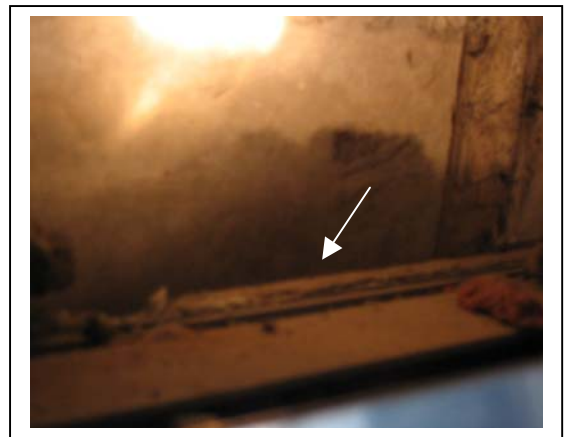
Plate 6: Asbestos cement sheet - Block 2 3rd Floor sheet behind lift indicator panel.

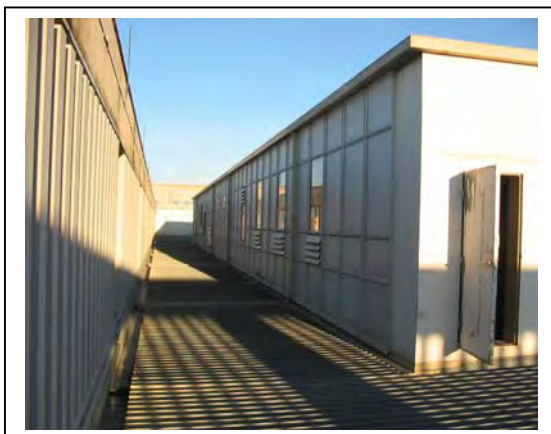
Plates 7: Asbestos Cement Sheet – Block 2 Exterior Plant Room.

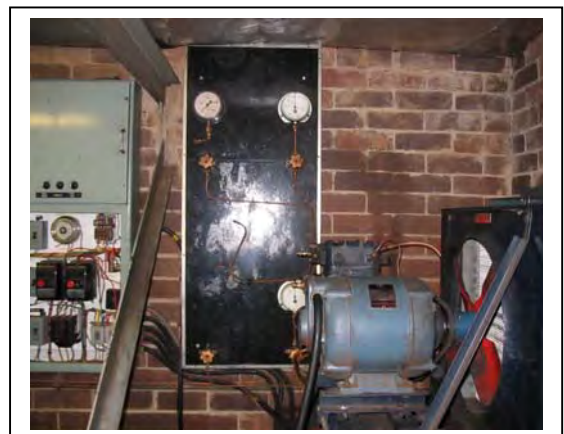
Plate 8: Asbestos Electrical Board - Cafeteria Air Handling Unit Plant Room.

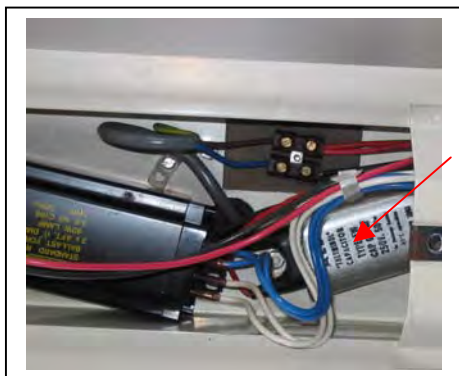
Plate 9 : ANZAC Park West PCB Containing Capacitor

It is recommended that if these capacitors are to be removed appropriate PPE should be worn and they should be disposed of as PCB waste in accordance with local requirements.

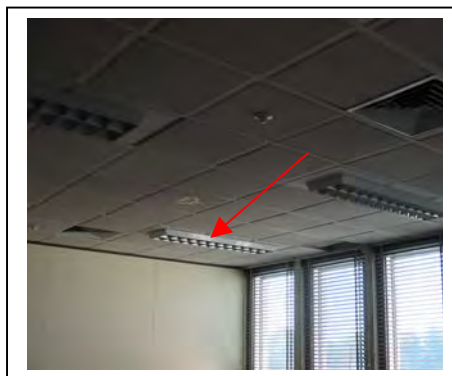
Plate 10 : ANZAC Park West Typical Office Floor PCB Light Fittings
