National Security
Office Precinct

Annual Compliance Report 2024

John Gorton Campus Car Park
EPBC Ref: 2022/09400

John Gorton Carpark Project Tree Audit March 2024

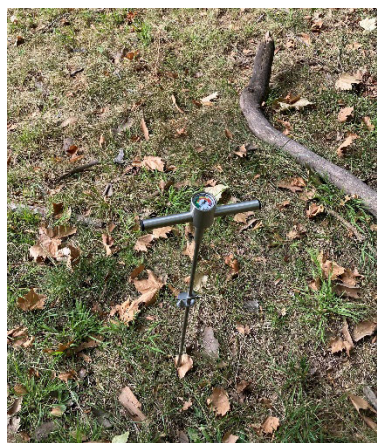
Soil compaction probing was carried out using a standard soil penetrometer with a 13mm probe head. Soil compaction measurements were taken at 100, 200 and 300mm.

Measurement of soil compaction will provide insight into ground conditions and impacts from environmental influences.

Soil compaction probe. Image credit [REDACTED]

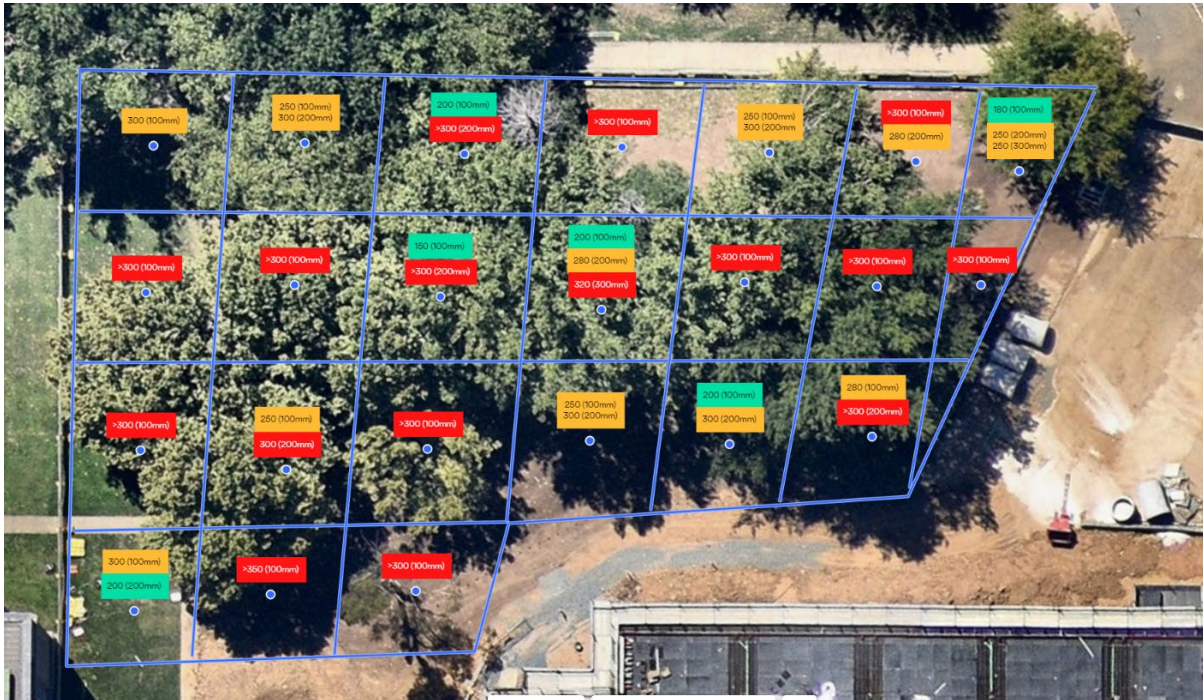
Figure 1 Soil Compaction results conducted on the 8/03/2024. Imagery source – NearMaps

Soil compaction was tested using a soil penetrometer in a grid method. The results above are from several penetrations, providing an average outcome. Ideally, readings are done at 100, 200, 300 millimetres. Due to the density of the soil, it was difficult to gain good readings, with many sample areas not allowing any measurement below 50mm. These results are reflected in a singular marker of **>300 (100mm)**.

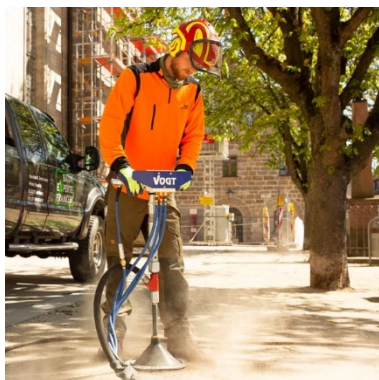
VOGT Geo-injector. Image courtesy
VOGT Baugeräte GmbH

For dry soil the injection area should be watered with a watering system 3 days before, for about 3 h daily. During decompaction, fissures in the soil will be backfilled with injectable materials designed to aid in soil improvement.

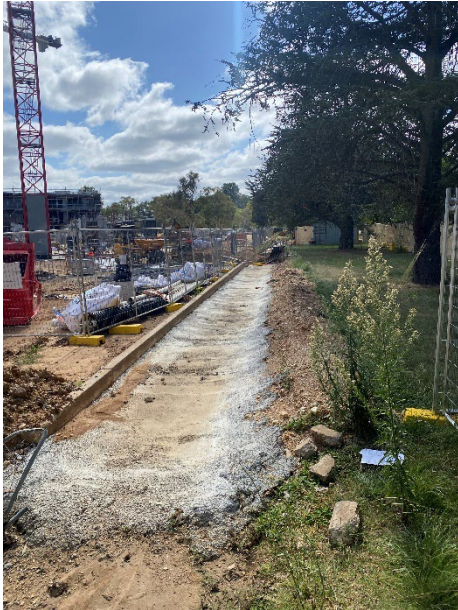
Spoon drain along row of cedars. Image credit [REDACTED]

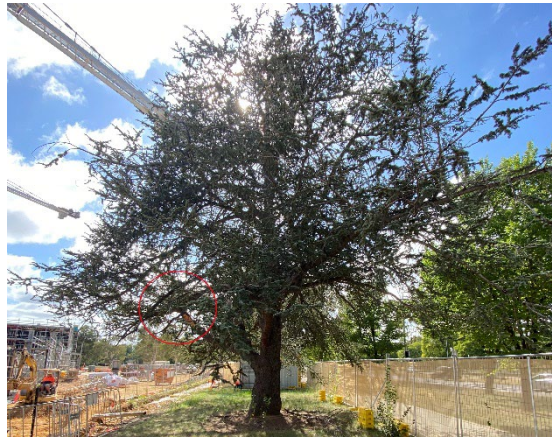
Two cedars on the Kings Avenue side present with storm damaged limbs. These require pruning of broken stubs. (trees 11603, 11636)

Example of observed storm damage. Image credit [REDACTED]

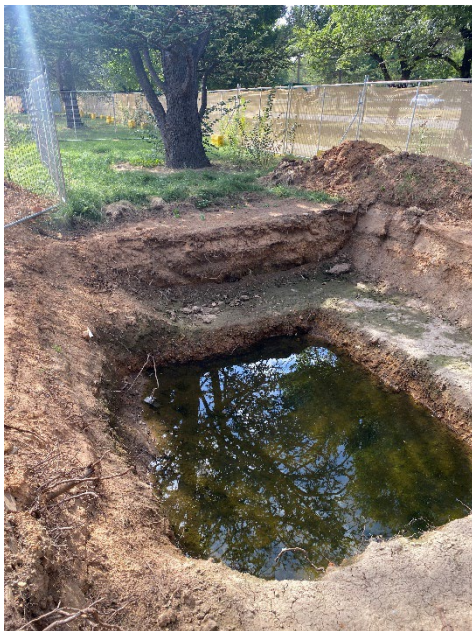
Structural root loss was minimal, with feeder roots being the most affected. The impact to these trees will likely not surface for some months, though it can be assumed that the loss of feeder roots within the excavation area will have a measurable impact. This can be mitigated with works recommended in this report.

Excavation within TPZ. A review of the roots cut during this dig showed a minimal amount of roots above 20mm diameter were cut.

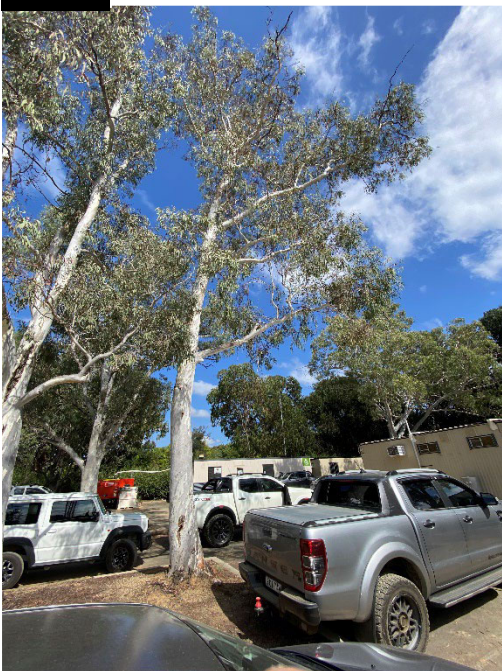
E. mannifera with minor deadwood. Image credit [REDACTED]

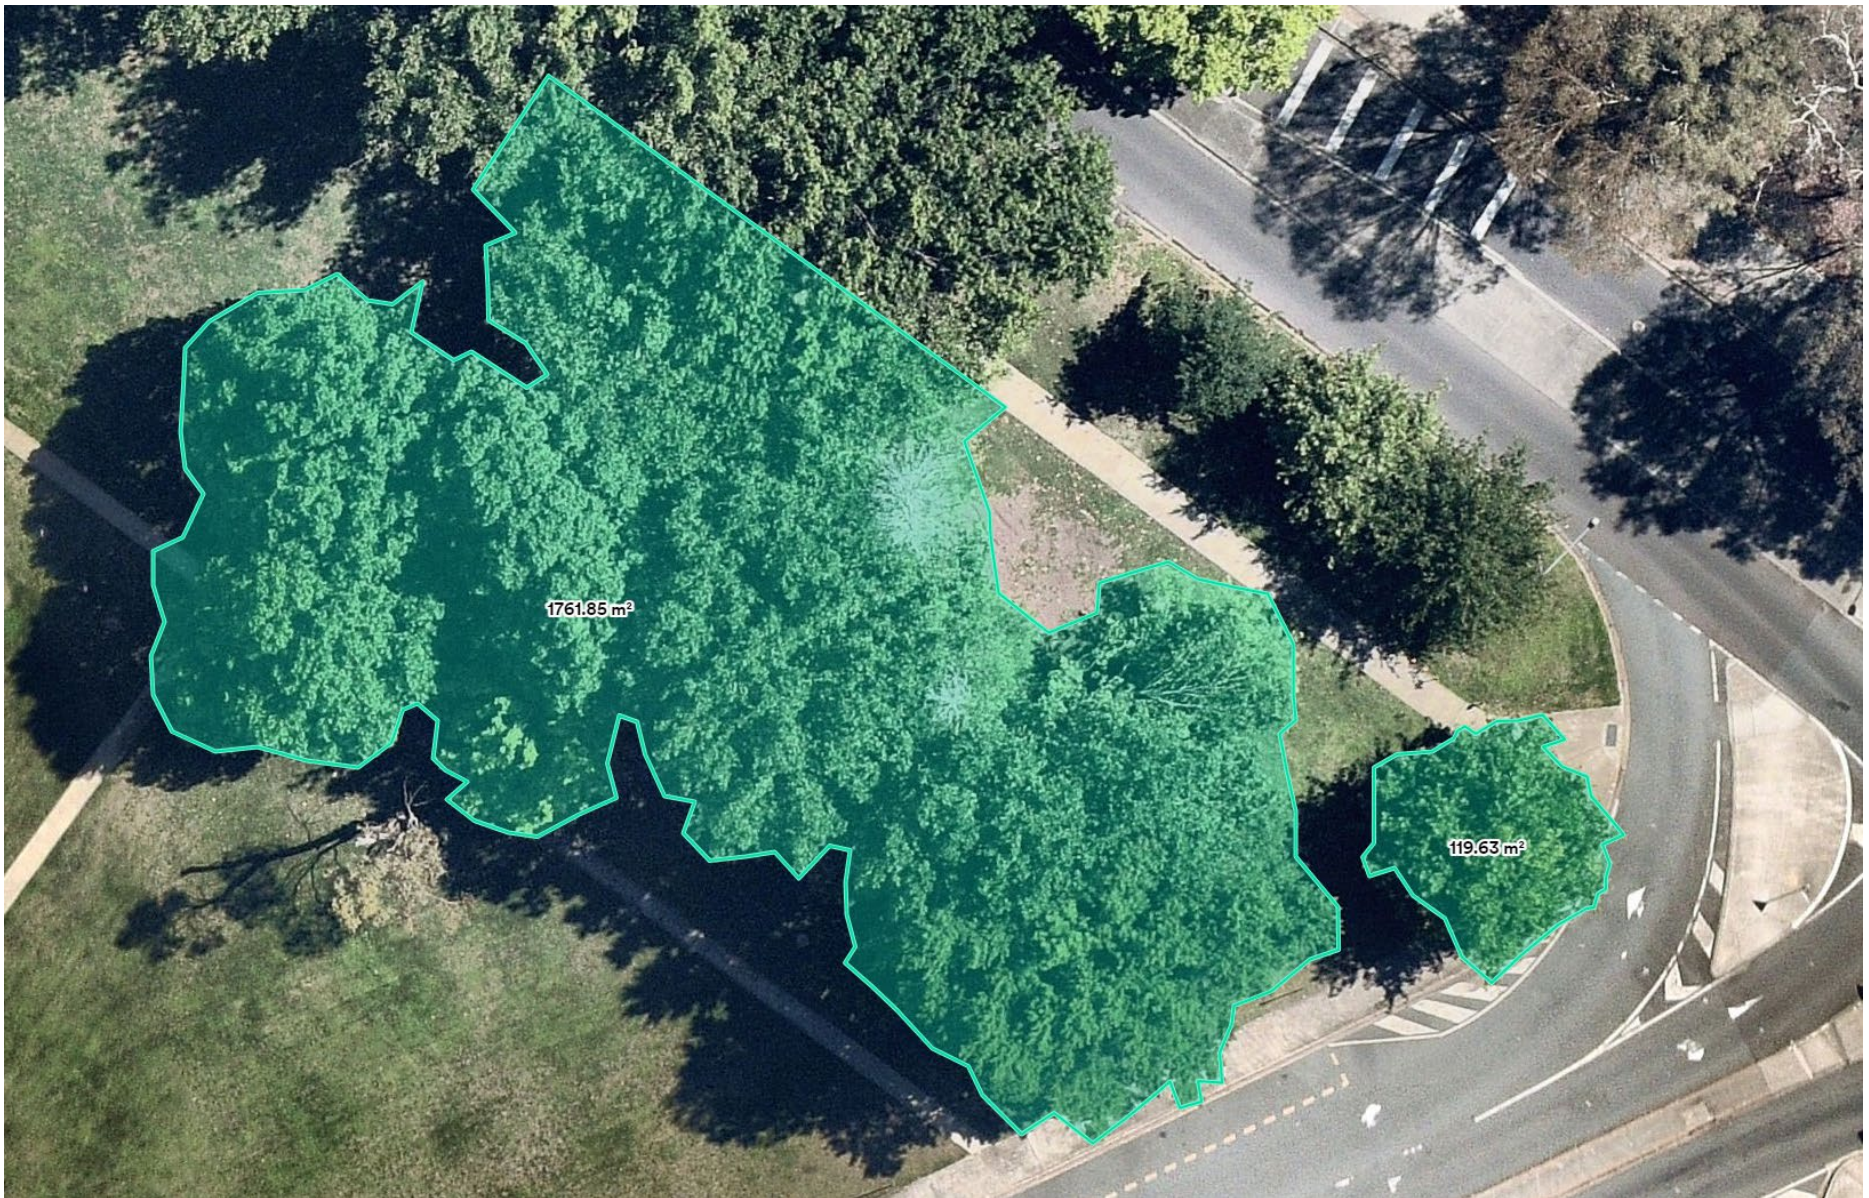
Comparing canopy coverage from 25/02/2024 and 11/02/2023 (Figure 1.1 & 1.2), There is an upward trend of canopy growth. However in December 2023, the Canberra region suffered repeated severe storms which led to several branch failures and one tree failure in the construction area. A comparative review of canopy coverage for the most impacted group of trees shows a decrease of canopy.

Figure 1.1 Canopy measurement as of 11/02/2023

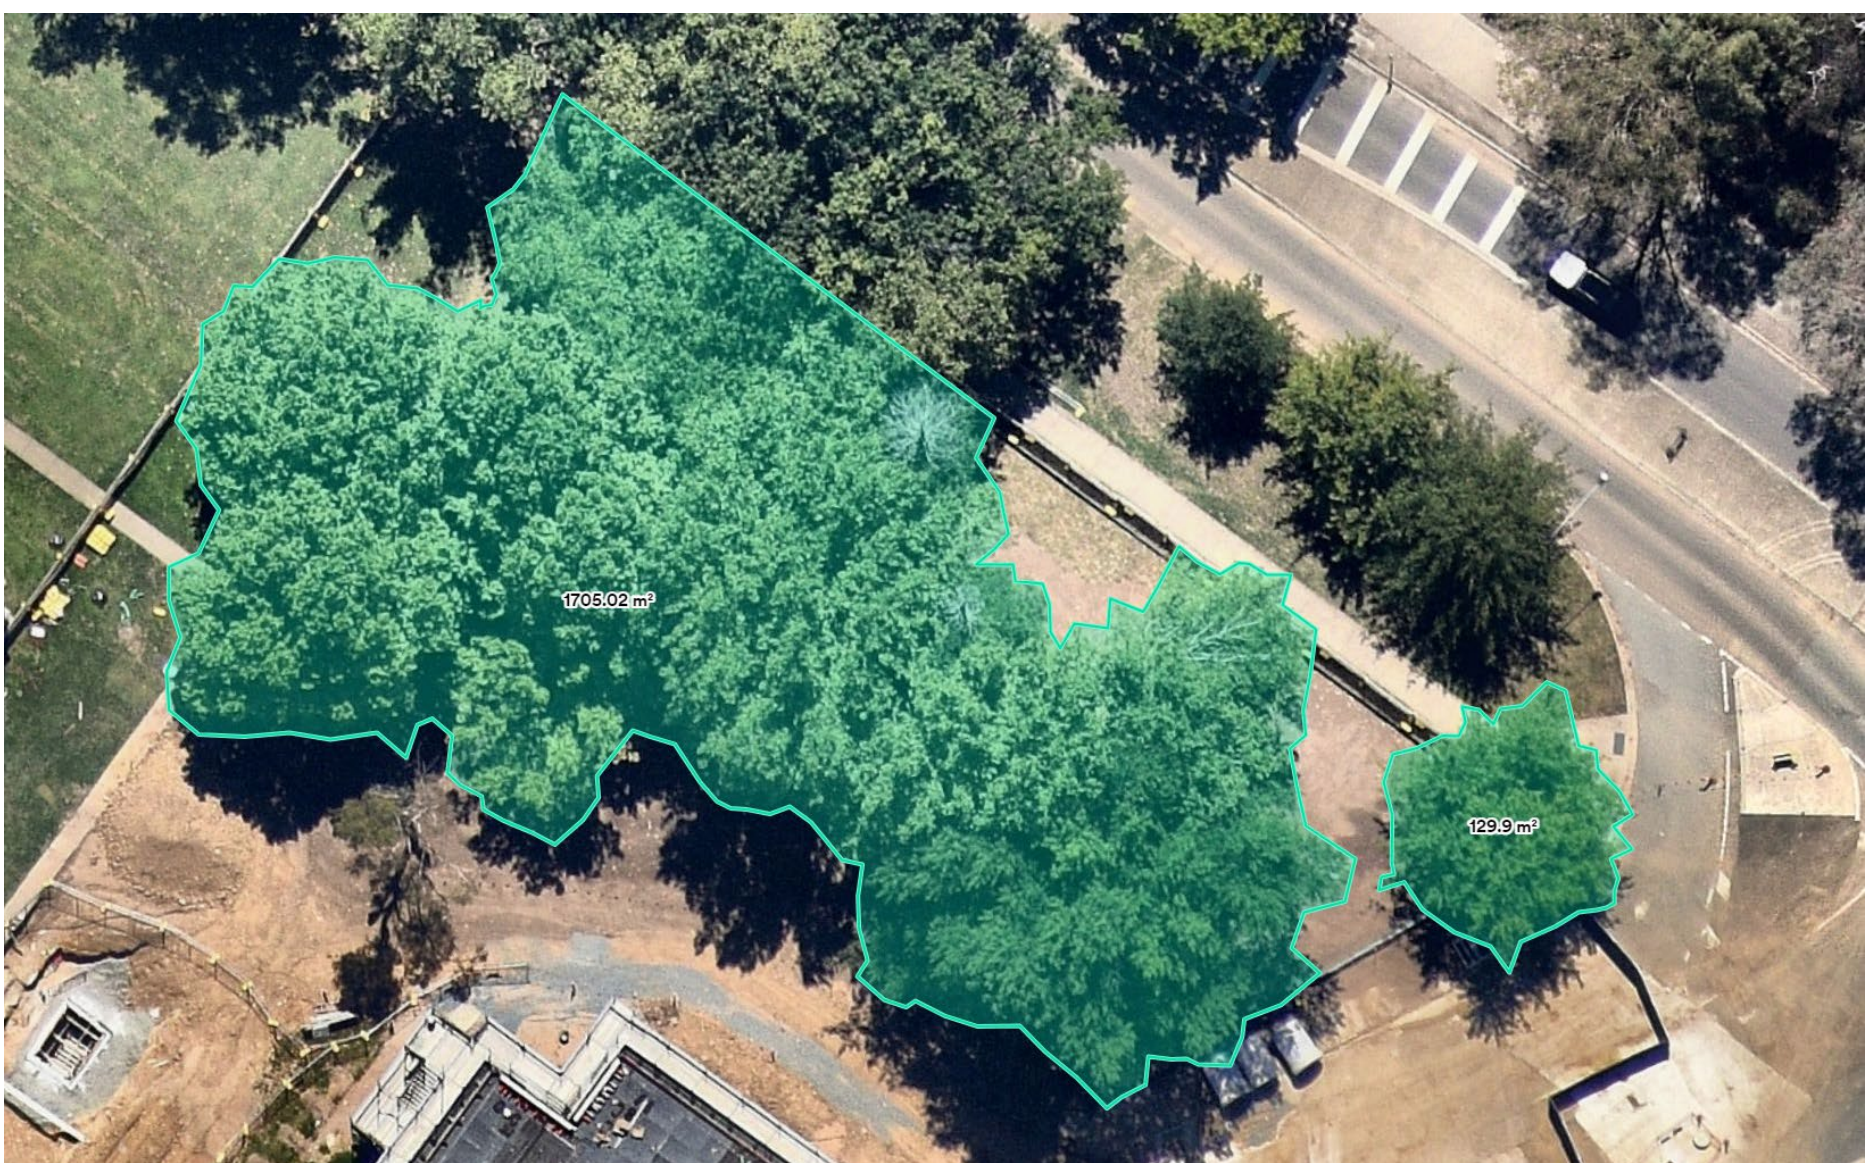
While coverage has gone down, attributed from required clearance pruning and storm damage, the relative density of leaf mass has not.

Figure 1.2 Canopy measurement as of 25/02/2024

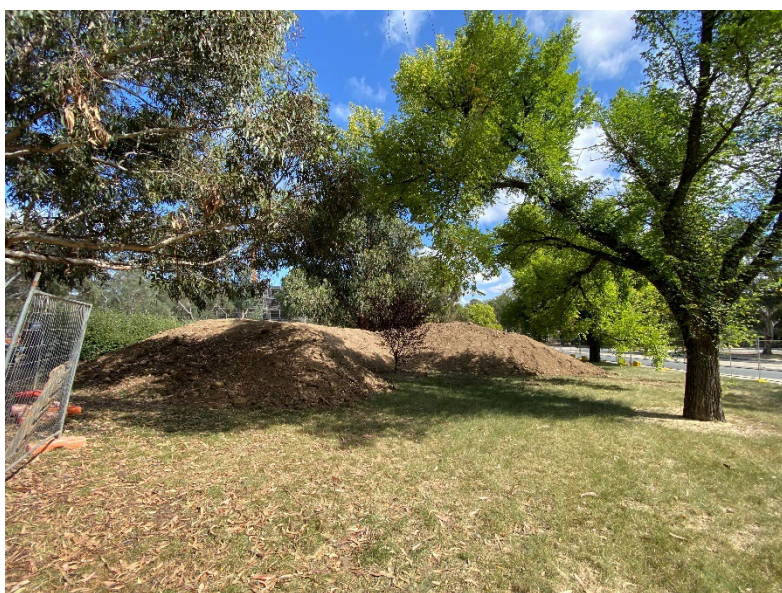
While as a temporary feature the impact would be negligible. However if it remains in place for any longer than 3 months, it may start to alter the soil profile and ability for the trees to obtain water and nutrients. Oxygen cutoff will kill off fine root systems under the soil.

Northern side of soil deposit. Image credit [REDACTED]

Gold Leaf was advised that the presence of this soil is a temporary measure, and will be relocated as soon as practicable.

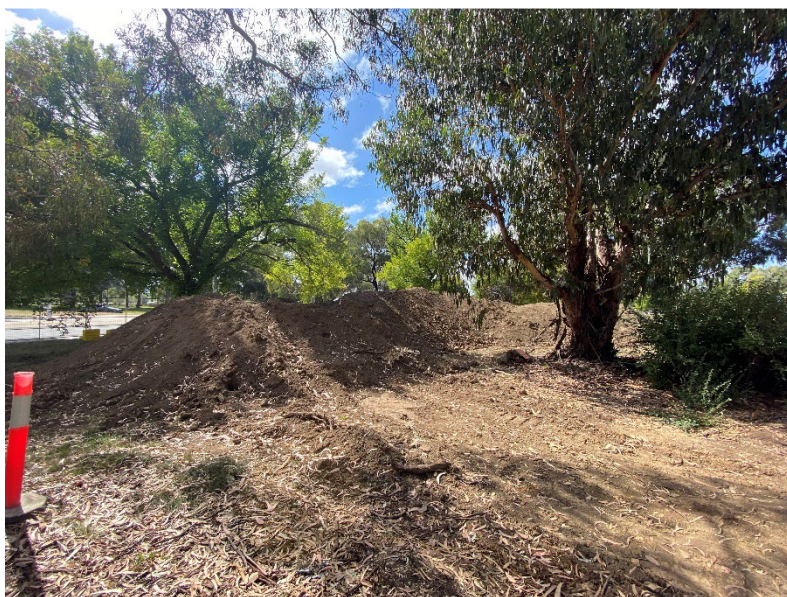
Southern side of soil deposit. Signs of machinery within a *Eucalyptus bicostata*'s drip line are shown. Image credit [REDACTED]
