National Security  
Office Precinct

# Annual Compliance Report 2025

John Gorton Campus Car Park  
EPBC Ref: 2022/09400

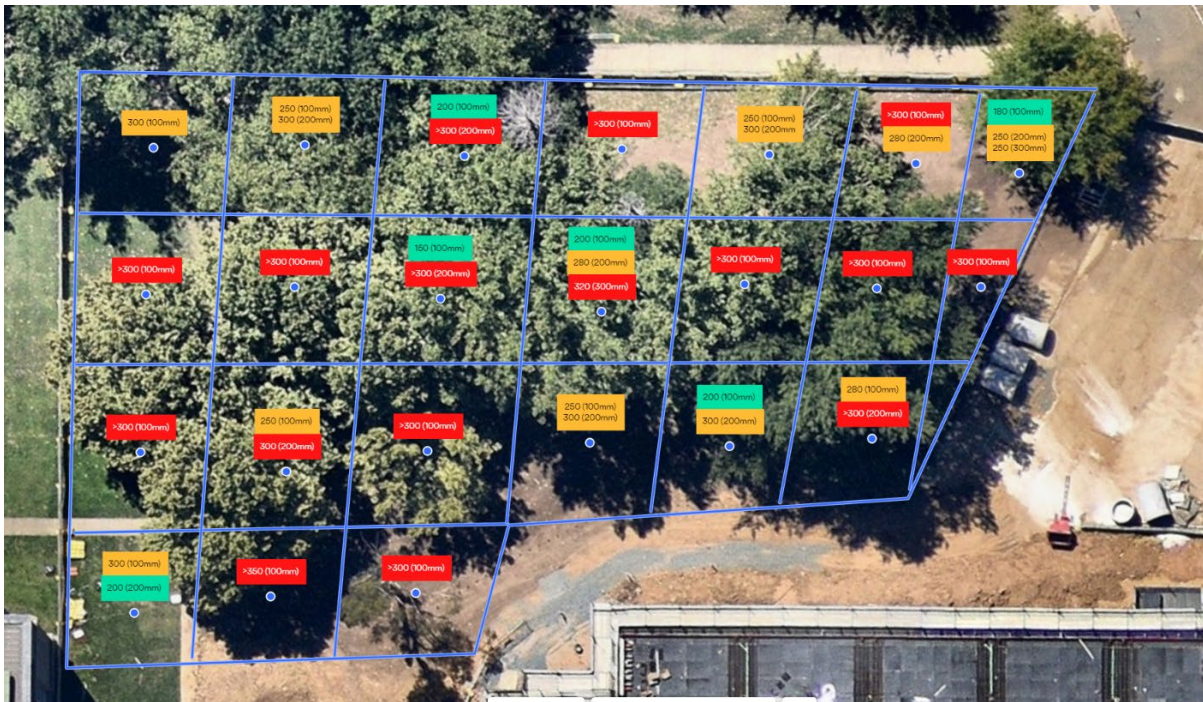
Figure 1 Soil Compaction results conducted on the 8/03/2024. Imagery source – NearMaps

Soil compaction was tested using a soil penetrometer in a grid method. The results above are from several penetrations, providing an average outcome. Ideally, readings are done at 100, 200, 300 millimetres. Due to the density of the soil, it was difficult to gain good readings, with many sample areas not allowing any measurement below 50mm. These results are reflected in a singular marker of **>300 (100mm)**.

Conditions on the ground present as dry, and highly compacted. After recent flooding in late December, a noticeable amount of fine soil has settled in the surface, increasing the compaction

### **Decompaction of compacted soil, focusing on higher affected areas.**

Air assisted soil decompaction utilizing a VOGT Geo-Injector.

Placing high quality mulch within a trees drip line is shown to increase soil quality, reduce compaction, and aid in water retention. It is recommended to mulch in a 2m radius around each tree in the compacted area. Considering the intended aesthetics of the area, maintaining a small radius of mulch will garner some benefit over the lifespan of the construction.

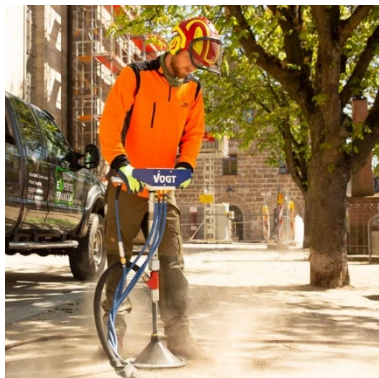
*VOGT Geo-injector. Image courtesy  
VOGT Baugeräte GmbH*

For dry soil the injection area should be watered with a watering system 3 days before, for about 3 h daily. During decompaction, fissures in the soil will be backfilled with injectable materials designed to aid in soil improvement.

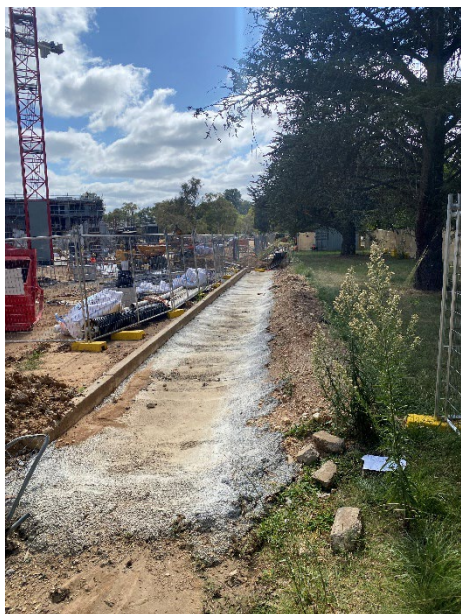
Cedars along Kings Avenue have had a spoon drain installed along the inside boundary of the TPZ. There is no observable change in canopy density. A small amount of deadwood exists within these trees. Upon inspection of these dead branches show that these dead branches have sat for longer than 12 months.

Spoon drain along row of cedars. Image credit [REDACTED]

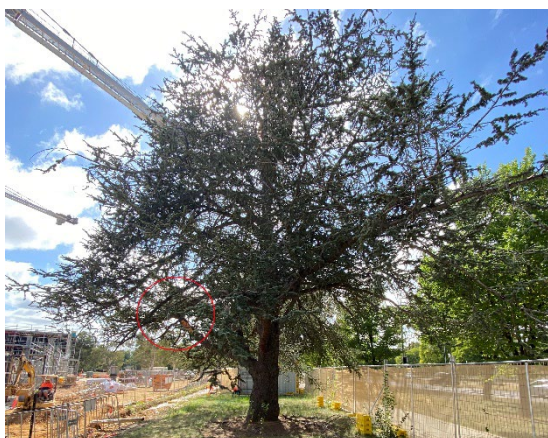
Two cedars on the Kings Avenue side present with storm damaged limbs. These require pruning of broken stubs. (trees 11603, 11636)

Example of observed storm damage. Image credit [REDACTED]

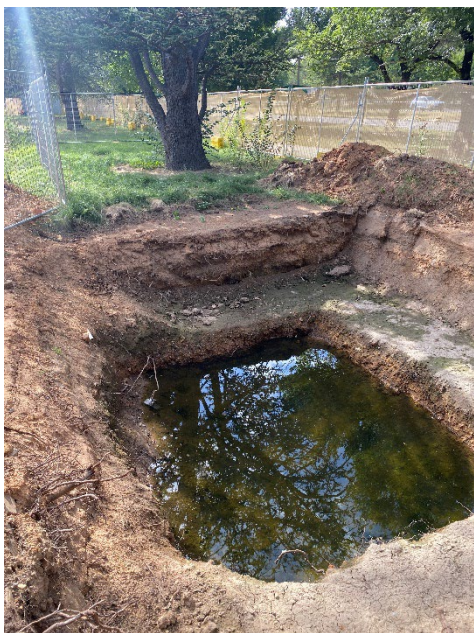
Excavation within TPZ. A review of the roots cut during this dig showed a minimal amount of roots above 20mm diameter were cut.

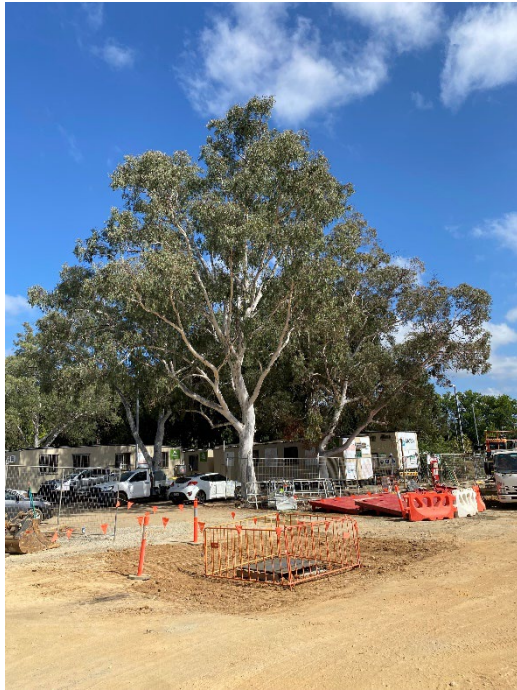
The trees located within the designated site office area have not seen drastic changes to canopy density or shape. Some smaller branches have been observed as storm damaged from the Dec 2024 storms.

*E. mannifera* in site office carpark. Image credit [REDACTED]

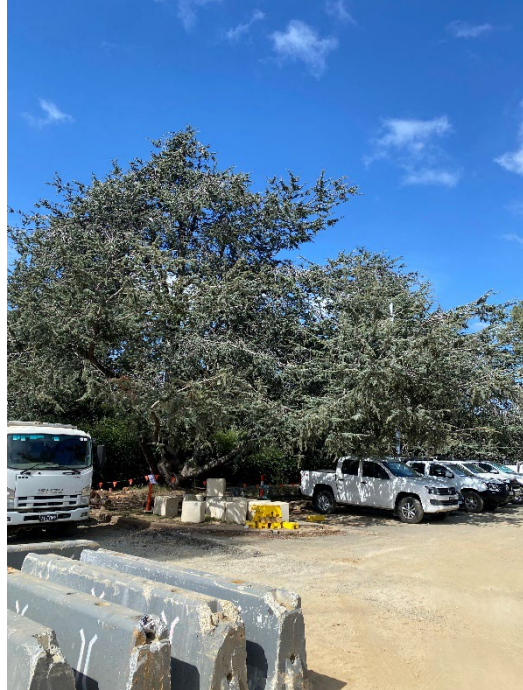
*C. atlantica* in site office carpark, alongside southern edge of construction. Image credit [REDACTED]

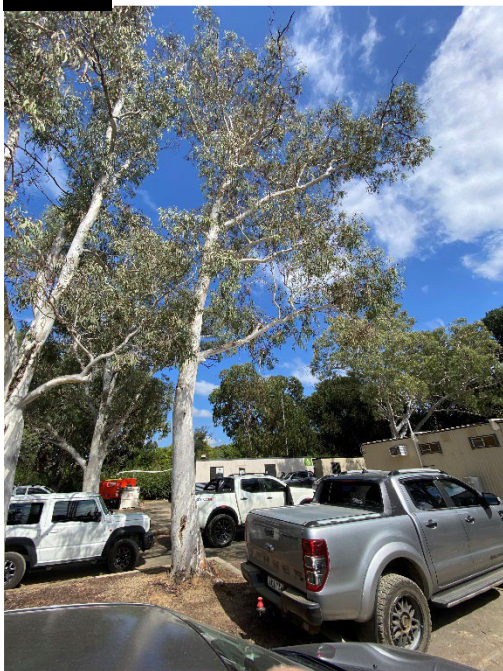
*E. mannifera* with minor deadwood. Image credit [REDACTED]

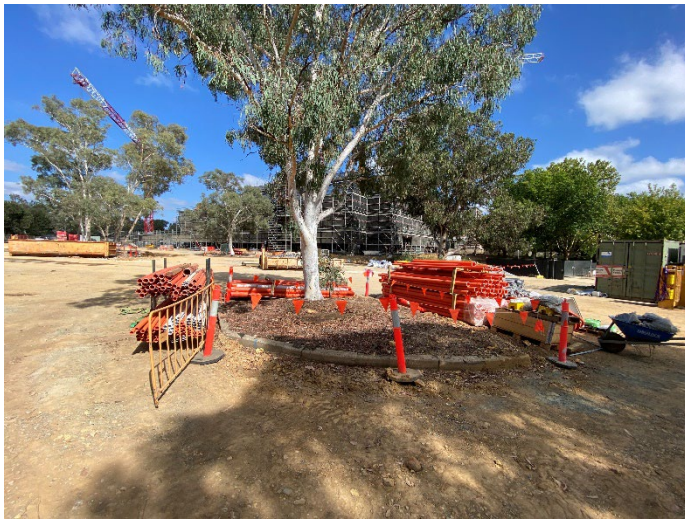
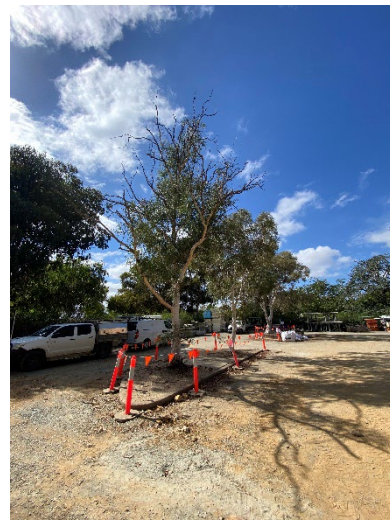
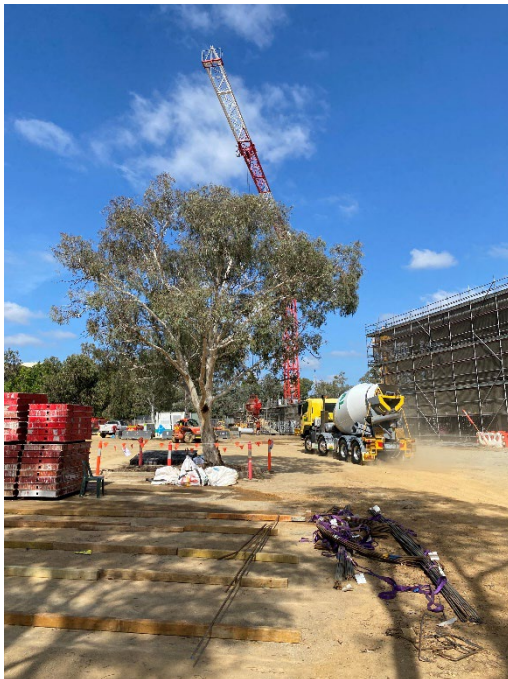
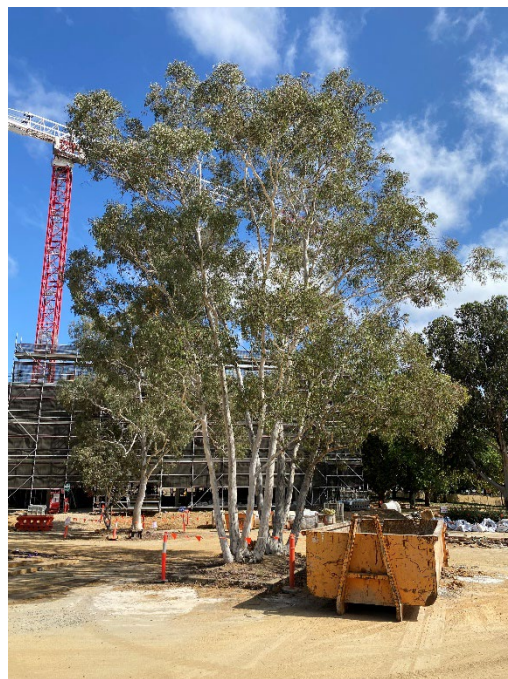
Observing the retained *Eucalyptus mannifera* along the Eastern side of the area, the protection zones consist of flagging around the concrete edging. While the plant/vehicle exposure to these trees are minimal when compared to the Western side, there is material and other storage being used in proximity to these trees. While I assess the likelihood of damage to these trees as low, changing the flagging to temporary fencing will provide a more visual barrier to drivers and load carrying machinery.

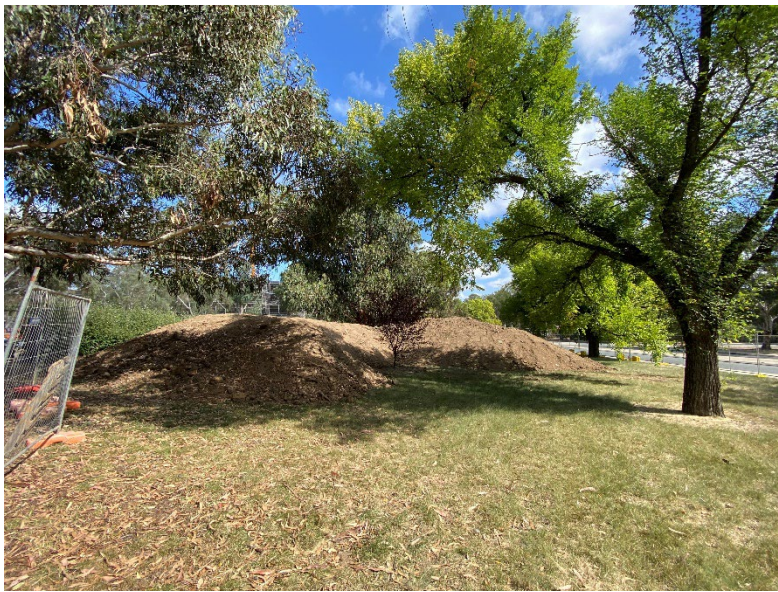
During the inspection on the 8/03/2024, it was discovered that a large deposit of soil had been placed within the TPZ of trees situated along King Edward Terrace.

While as a temporary feature the impact would be negligible. However if it remains in place for any longer than 3 months, it may start to alter the soil profile and ability for the trees to obtain water and nutrients. Oxygen cutoff will kill off fine root systems under the soil.

Northern side of soil deposit. Image credit [REDACTED]

Gold Leaf was advised that the presence of this soil is a temporary measure, and will be relocated as soon as practicable.

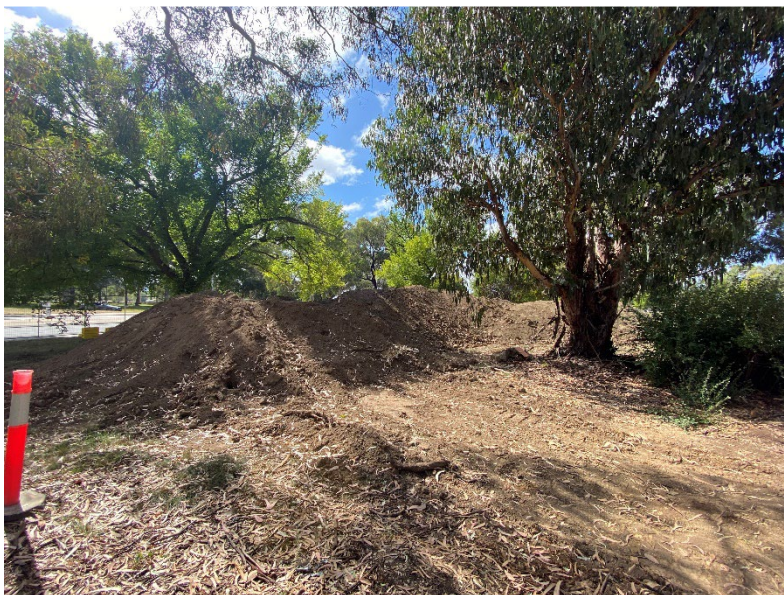
Southern side of soil deposit. Signs of machinery within a *Eucalyptus bicostata*'s drip line are shown. Image credit [REDACTED]

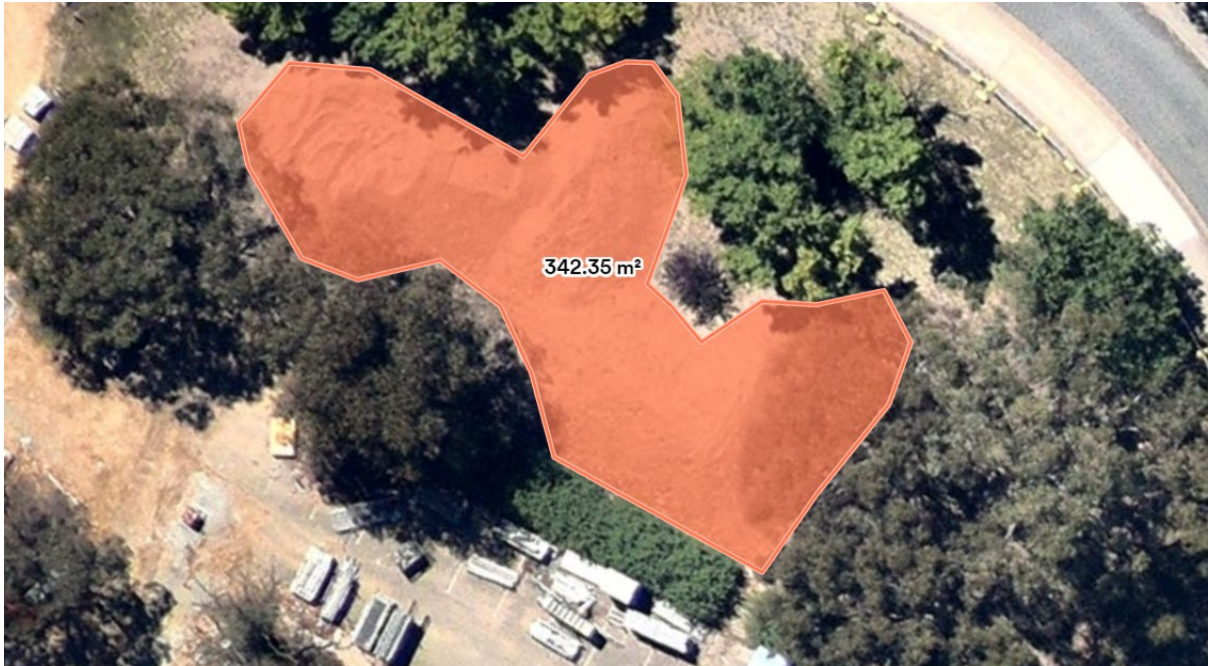
*Area of soil as shown through aerial imagery. Image credit NearMaps 2024.*
