## COMCAR INFORMATION/LOST PROPERTY REPORT

Type: (Tick as appropriate)	<input checked="" type="checkbox"/> ACCIDENT	<input type="checkbox"/> BREAKDOWN	<input type="checkbox"/> LATE VEHICLE	<input type="checkbox"/> RESERVATIONS
	<input type="checkbox"/> NO CONTACT	<input type="checkbox"/> COMPLAINT	<input type="checkbox"/> FYI/OTHER	<input type="checkbox"/> ALLOCATIONS
For FYI / Other, please provide details:	INCIDENT ON SENATE SLIP ROAD (BOULEVARDS)

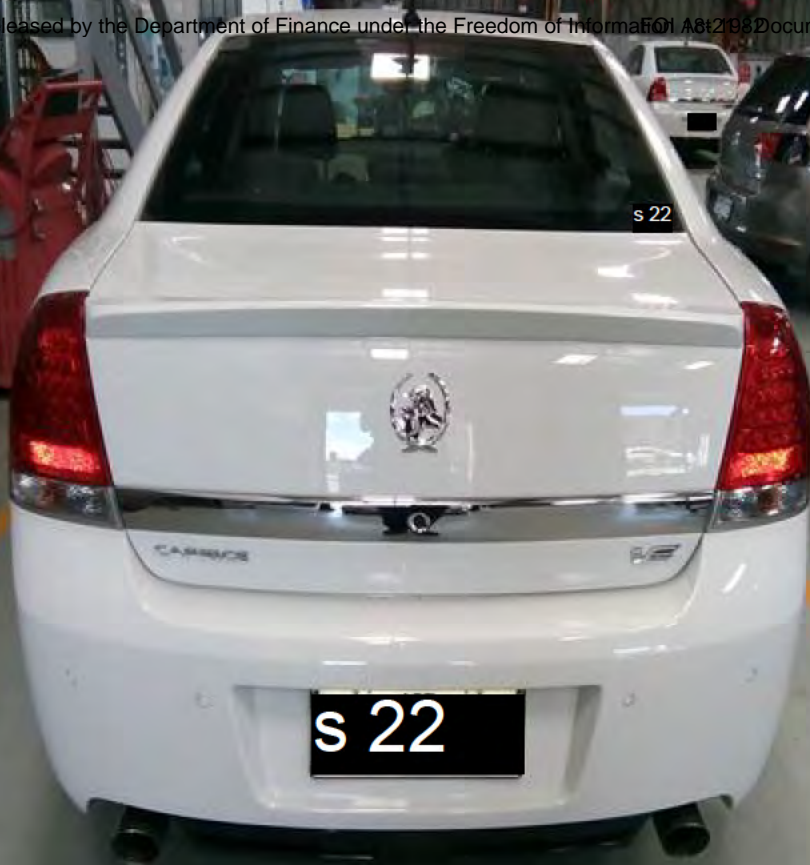
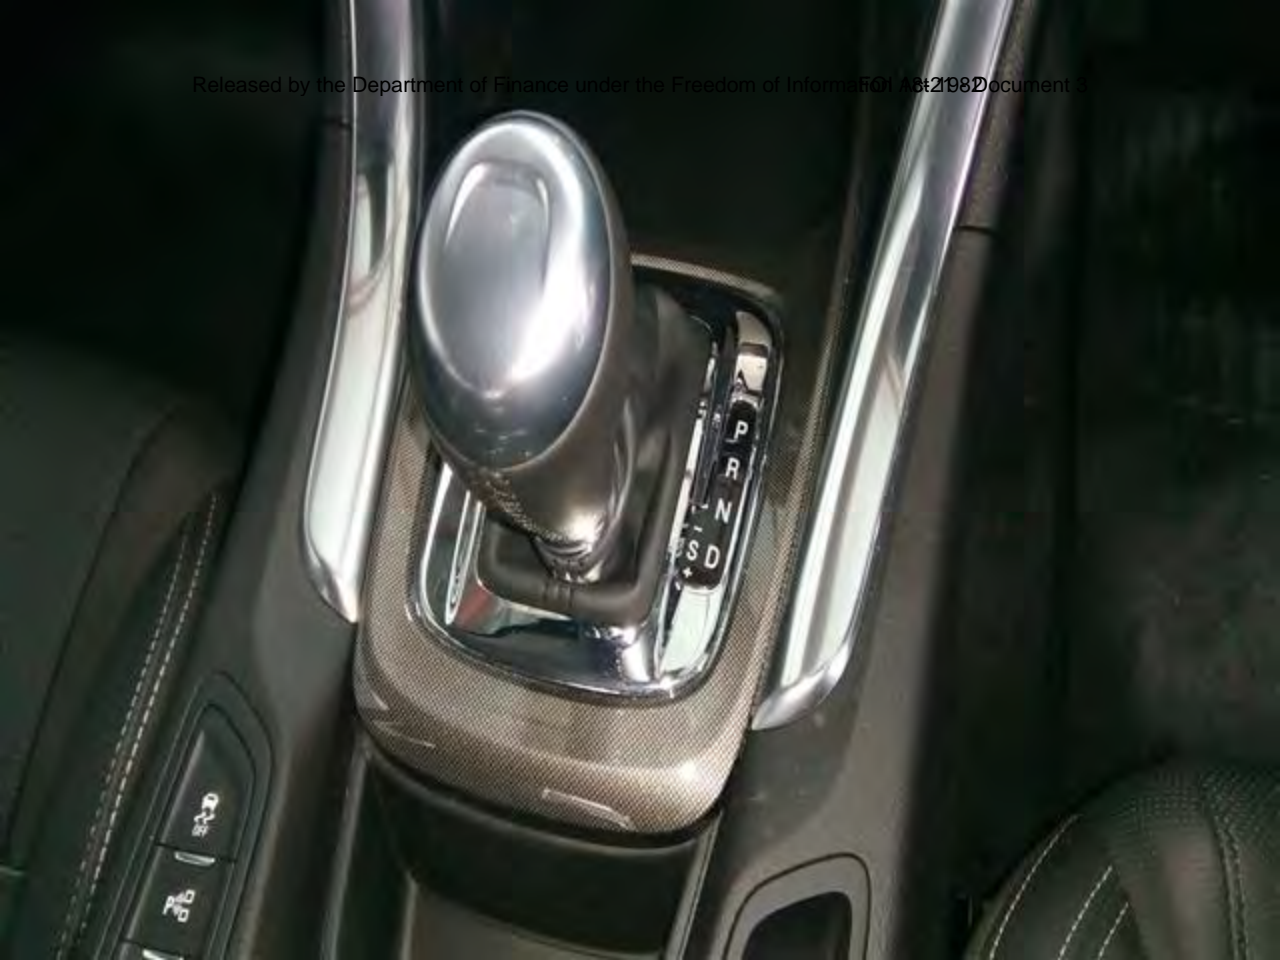
THE BOLLARD LIFTED THE FRONT END OF THE CAR. AND THEN LOWERED IT AGAIN.

THE CAR STALLED AND WOULD NOT RE START.

In regards to § 22 the transmission has been damaged due to impact. I have attached photos of the damage.

Below is the quote to repair;

GM-17804551, transmission asm-auto: § 22

GM-12640748, pan asm oil § 22

GM-92274700, rod kit-strg lnkg: § 22

**Total cost - \$7464.70 including GST**
